**NASA CR-159739
EDR 10085**

PLASMA-SPRAYED DUAL DENSITY CERAMIC TURBINE SEAL SYSTEM

FINAL REPORT

**DETROIT DIESEL ALLISON
DIVISION GENERAL MOTORS CORPORATION
INDIANAPOLIS, INDIANA 46206**

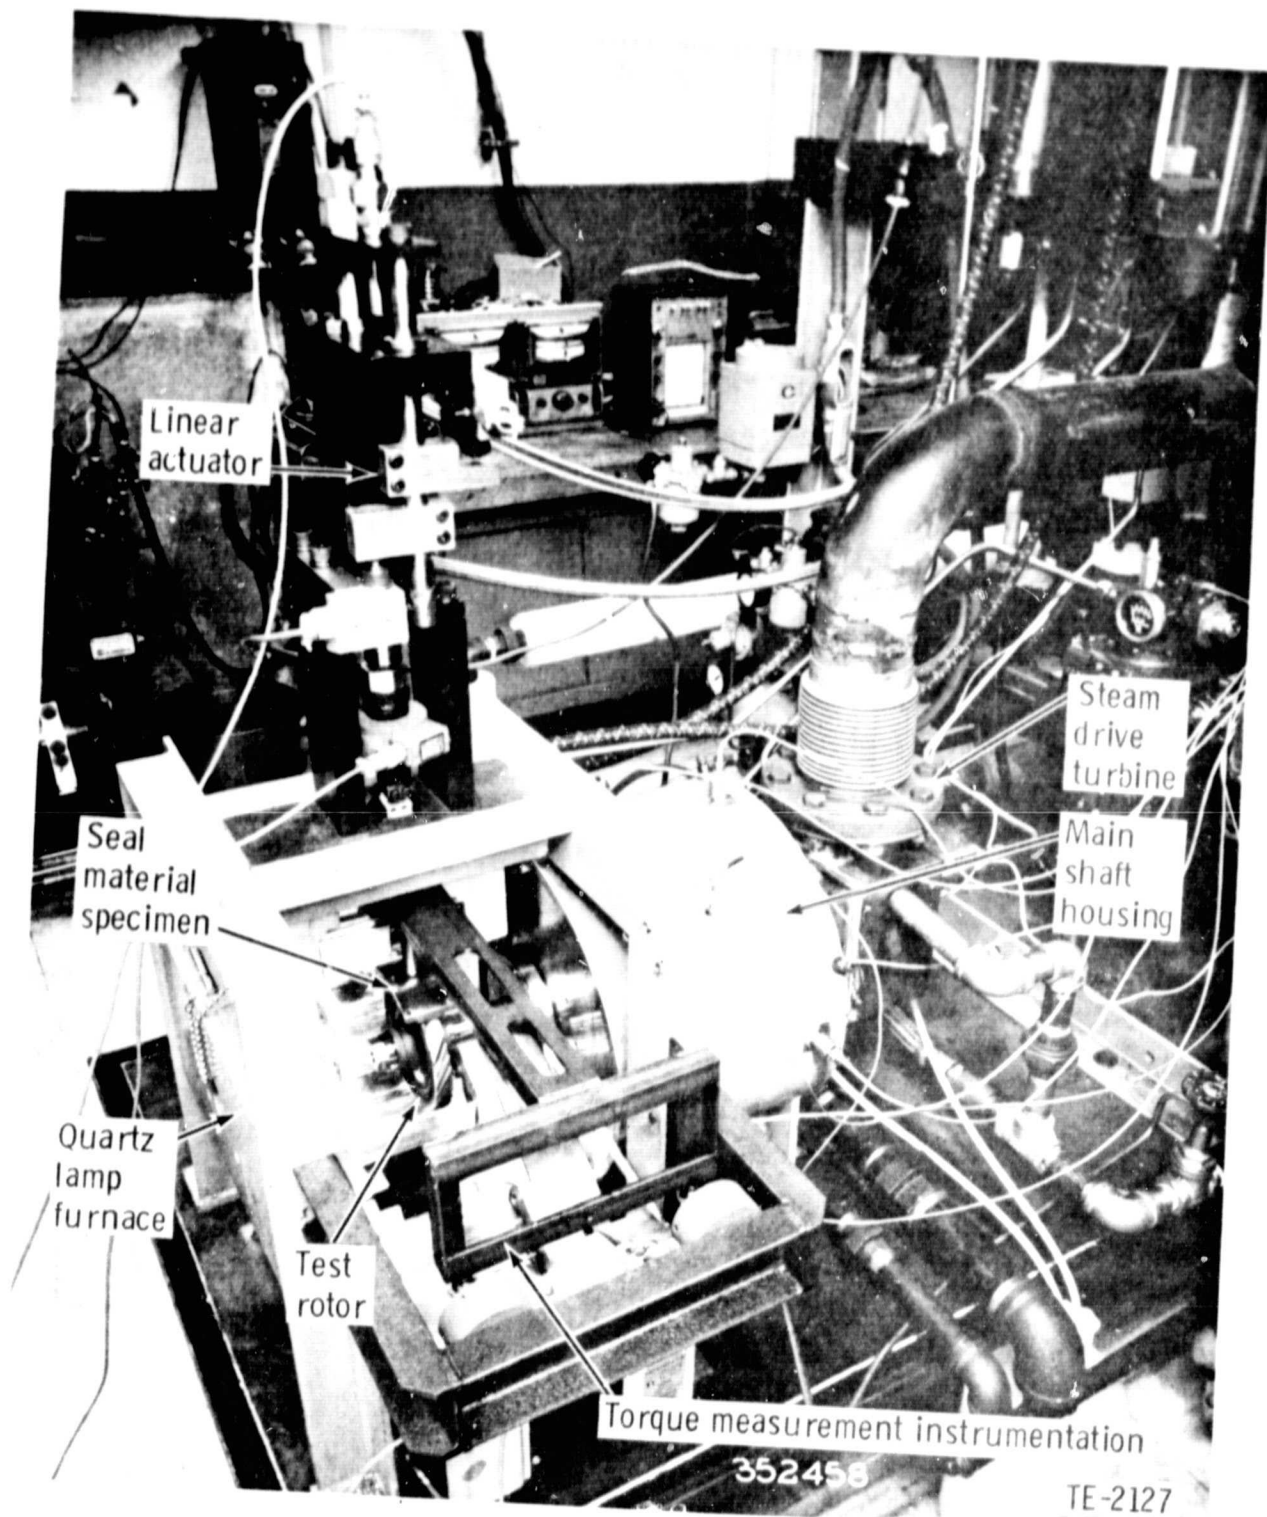
Figure 2 High-speed/high-temperature abrasable seal materials test rig

The abradability evaluations were conducted on the high speed, high temperature test rig shown in Figure 2. This rig consists of a steam turbine-driven spindle with replaceable test disks. The program test condition of 228.6 m/sec (750 ft/sec) requires the unit to rotate at 29,650 rpm, approximately one-half the design limit.

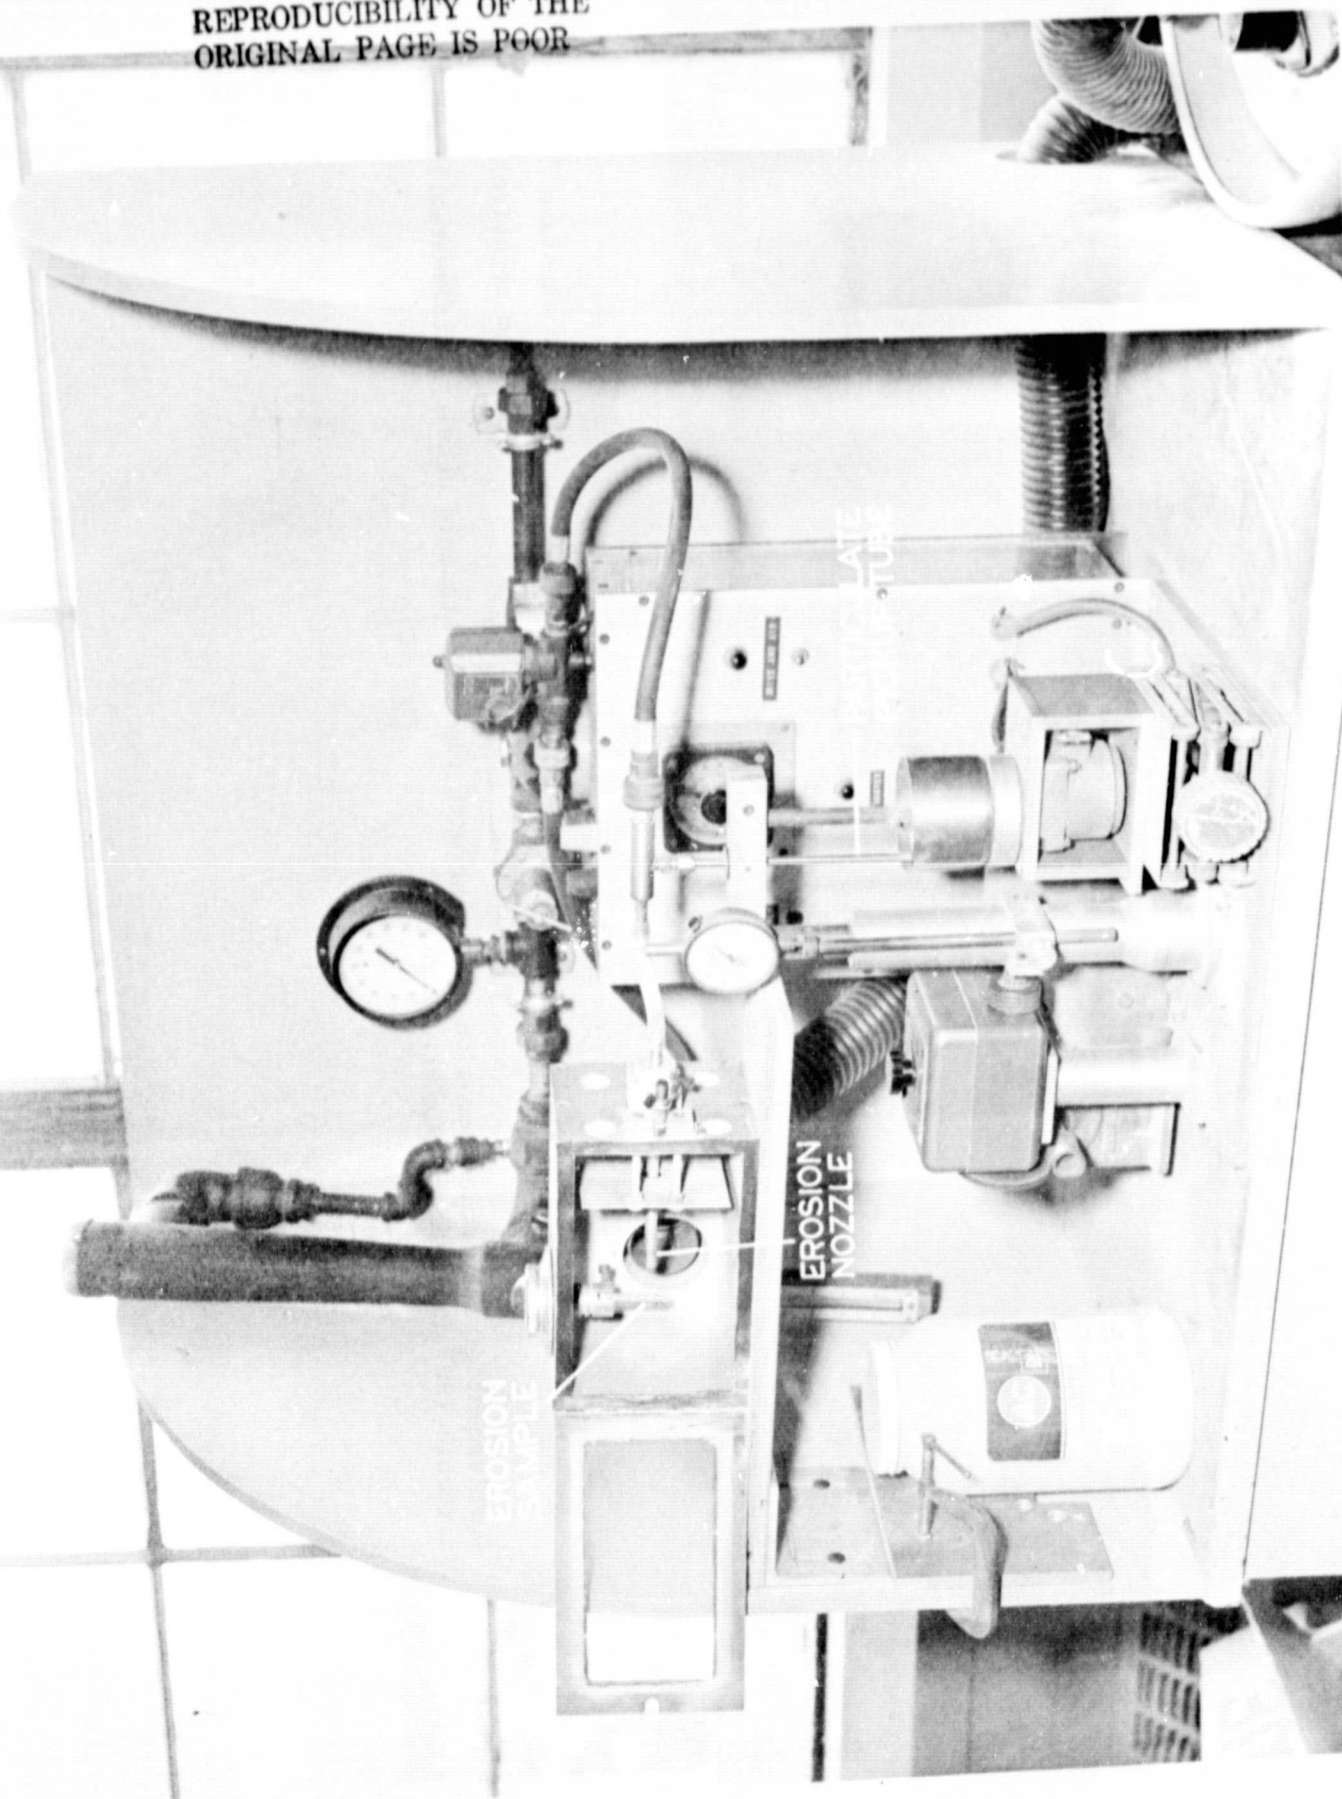
Figure 3 Erosion Test Rig

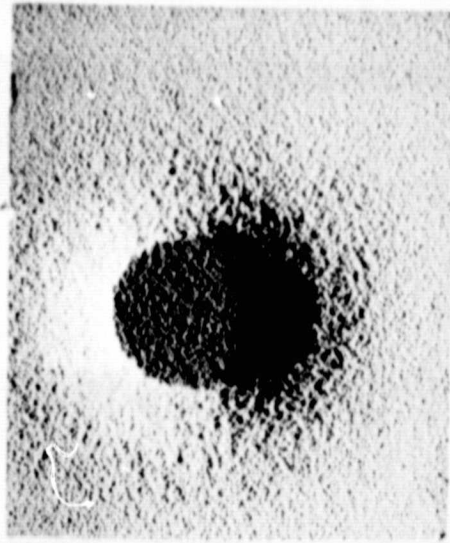
c. 60 min. exposure
(23.1 gm abrasive)

Figure 4 Development of accelerated erosion wear scar with time for standard density yttria-stabilized zirconia (90° impingement angle). Magn: 3X

The angular incidence of the specimen with respect to the erosive air stream was selected as 15° based on the tests of the standard density system shown in Figures 4 through 6. The 15° setting, Figure 6, was considered to be most representative of engine air flow conditions and would not unduly penalize candidate coating systems.

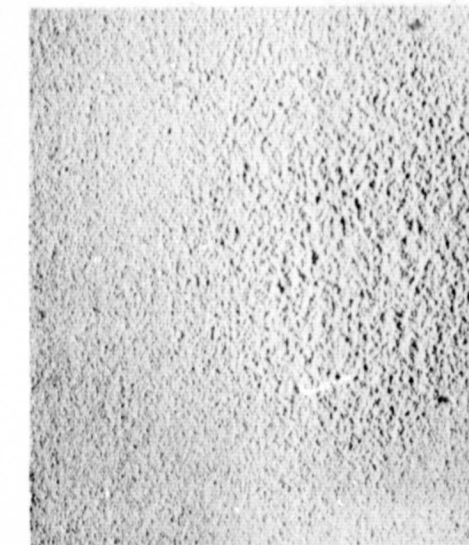
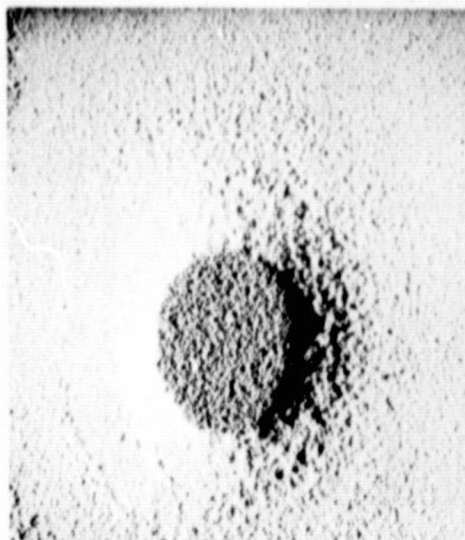
a. 30 min. exposure
(5.4 gm abrasive)

b. 60 min. exposure
(14.7 gm abrasive)

c. 120 min. exposure
(38.1 gm abrasive)

Figure 5 Development of accelerated erosion wear scar with time for standard density yttria-stabilized zirconia (45° impingement angle) Magn: 3X

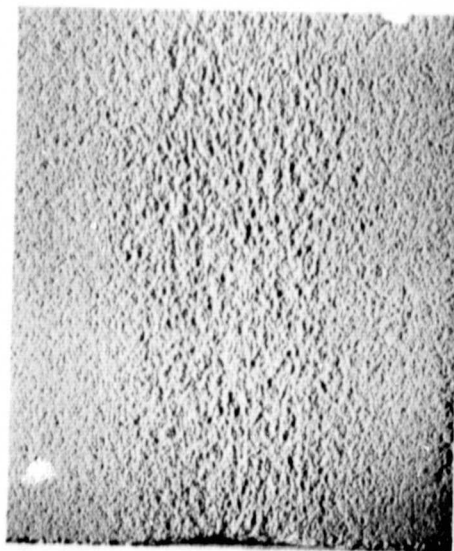
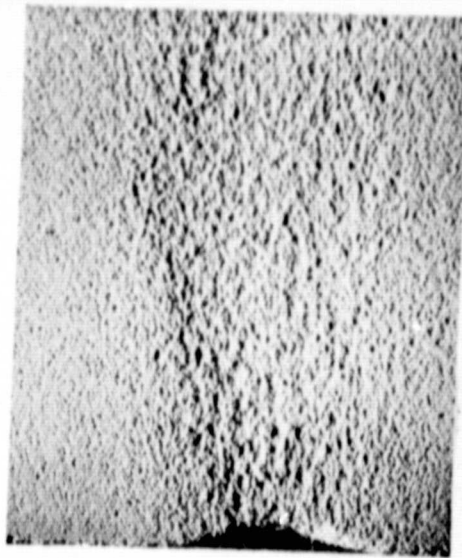
a. 30 min. exposure
(10.1 gm abrasive)

b. 60 min. exposure
(21.3 gm abrasive)

c. 120 min. exposure
(43.5 gm abrasive)

Figure 6 Development of accelerated erosion wear scar with time for standard density yttria-stabilized zirconia
(15° impingement angle) Magn: 3X

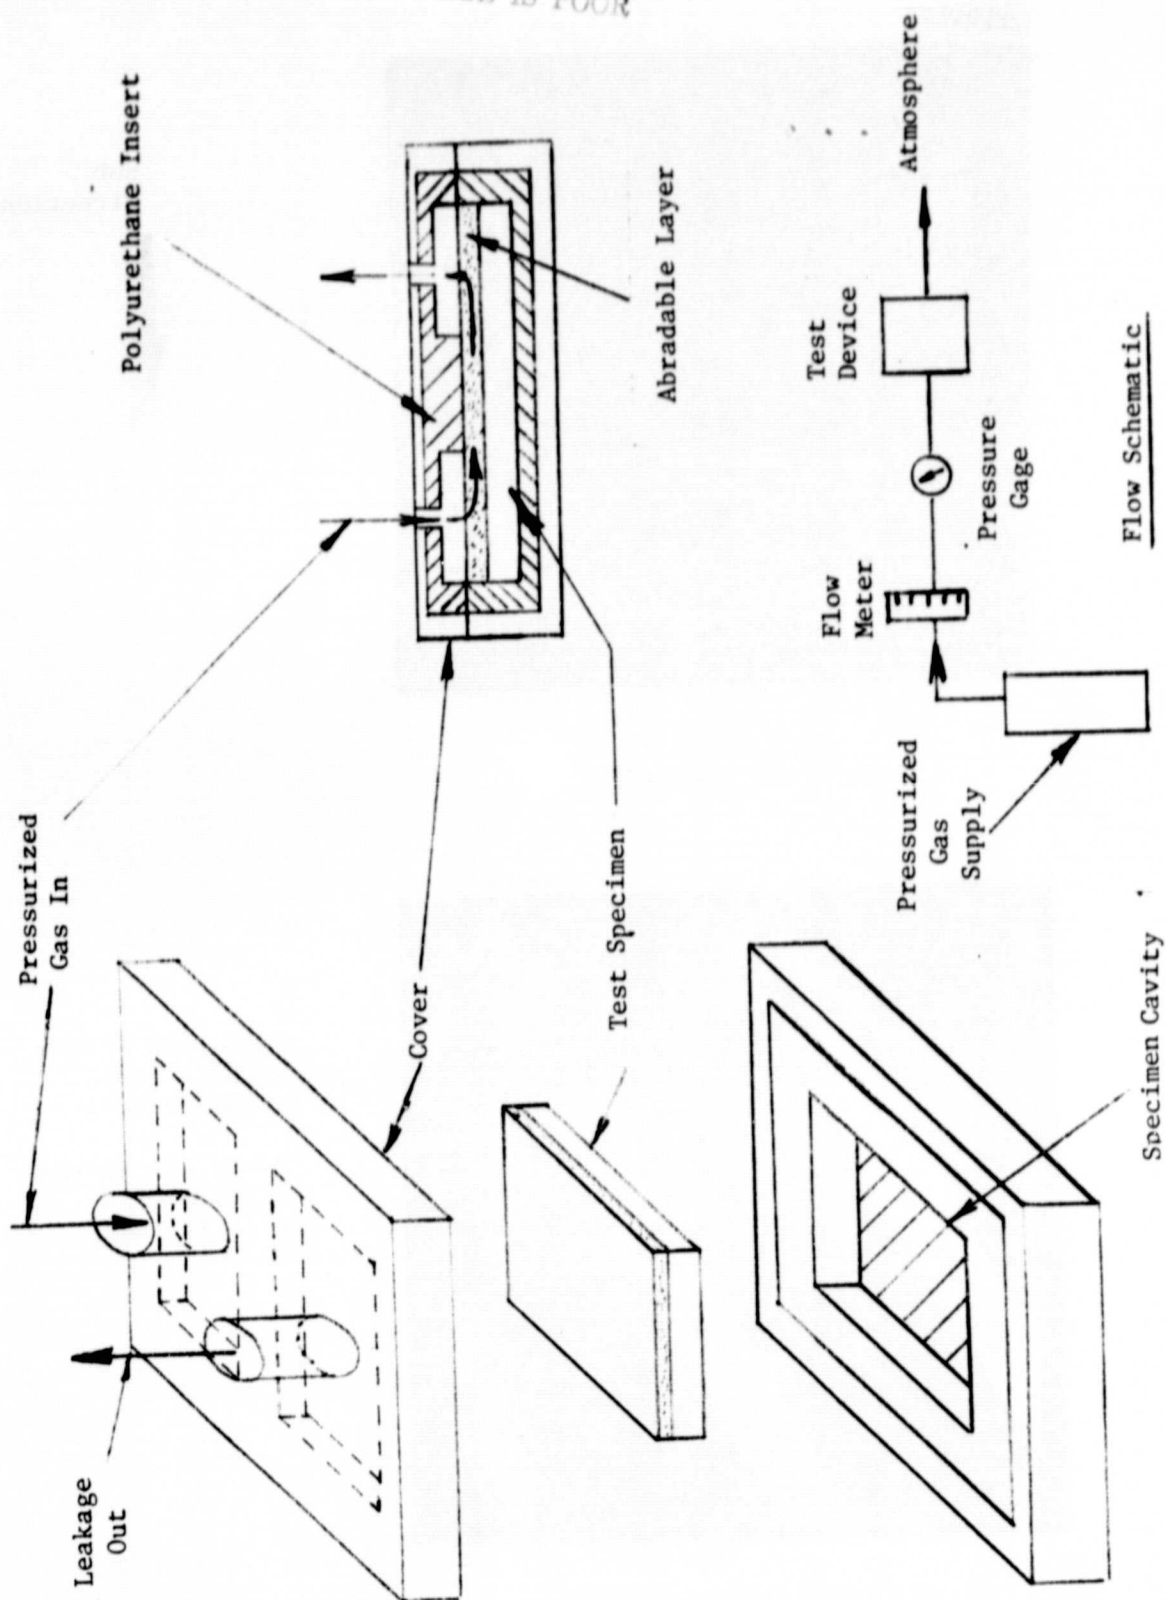
Figure 7 Permeability Test Device

Through-leakage as a result of interconnected porosity is evaluated on the rig schematically shown in Figure 7. This simple fixture consists essentially of inlet and exhaust ports which are formed in a polyurethane insert in the cover. When the cover is clamped in place over the sample, the polyurethane acts as a seal preventing leakage across the abradable surface to the exhaust port or to the atmosphere. The incoming argon is thereby forced to pass through the abradable material in order to reach the exhaust port. The feed port is connected to a pressure gage, flowmeter and argon tank and the exhaust port is open to the atmosphere. Pressure is set at the argon tank by means of a regulator, and through-flow in the coating is monitored at the flowmeter. The area used for the flow calculation is the actual cross sectional area of the specimen.

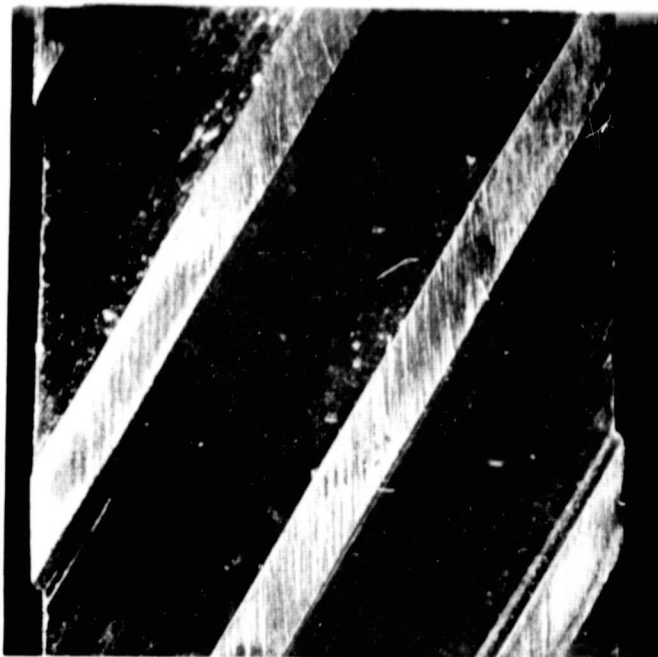
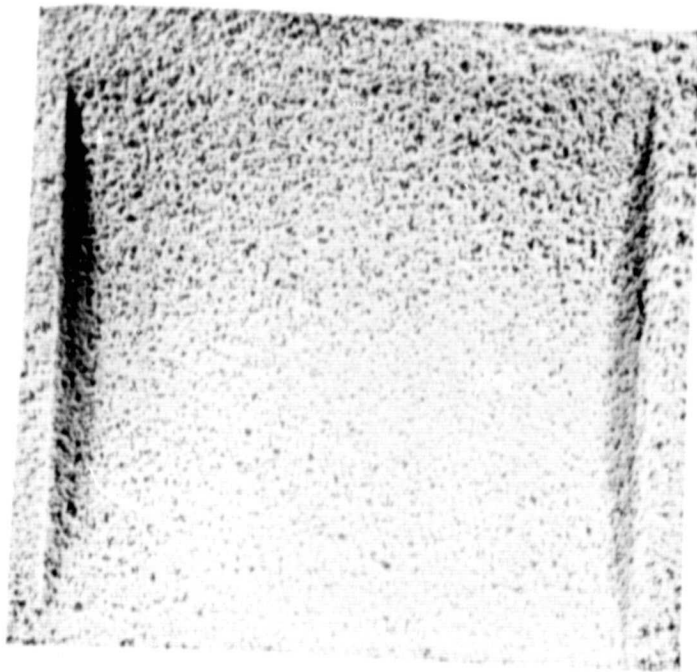
Blade track wear scar

Incursion rate:
.0025 cm/sec
(.001 in/sec)

Blade tip speed:
229 m/sec
(750 ft/sec)

Blade tip condition

Figure 8 Slow incursion rate abrasability test results for specimen configuration I-P Magn: 5X

The I-P polyester-filled system is shown in Figure 8 for the slow incursion rate of 0.0025 cm/sec. (0.001 in/sec.) The absence of transferred metal from the blade tip to rub track illustrates the fine abrasability characteristics of this material. The blade tip showed no evidence of distress or loss of material. A slight burnishing was present as can be seen by the faint discoloration of the tips in Figure 8. Depth of the rub was 0.013 cm (0.005 in.).

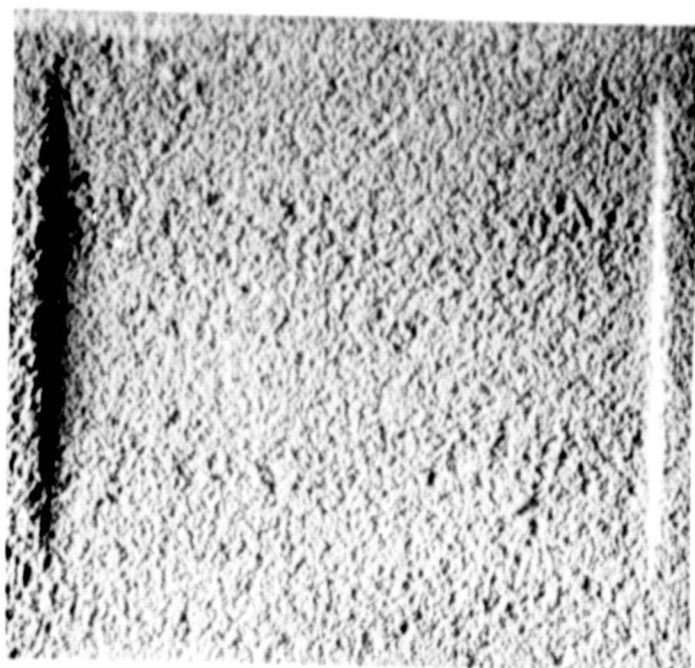
Blade track wear scar

Incursion rate:
.0025 cm/sec
(.001 in/sec)

Blade tip speed:
229 m/sec
(750 ft/sec)

Blade tip condition

Figure 9 Slow incursion rate abrasability test results
for specimen configuration II-P Magn: 5X

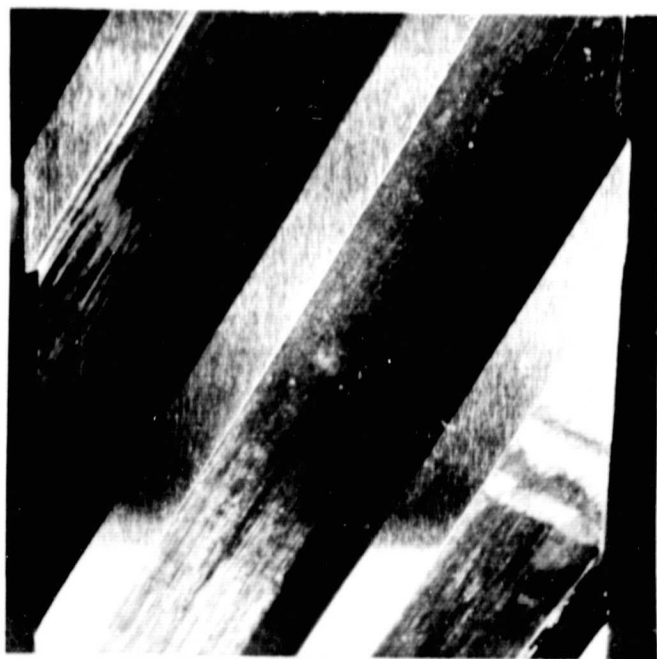
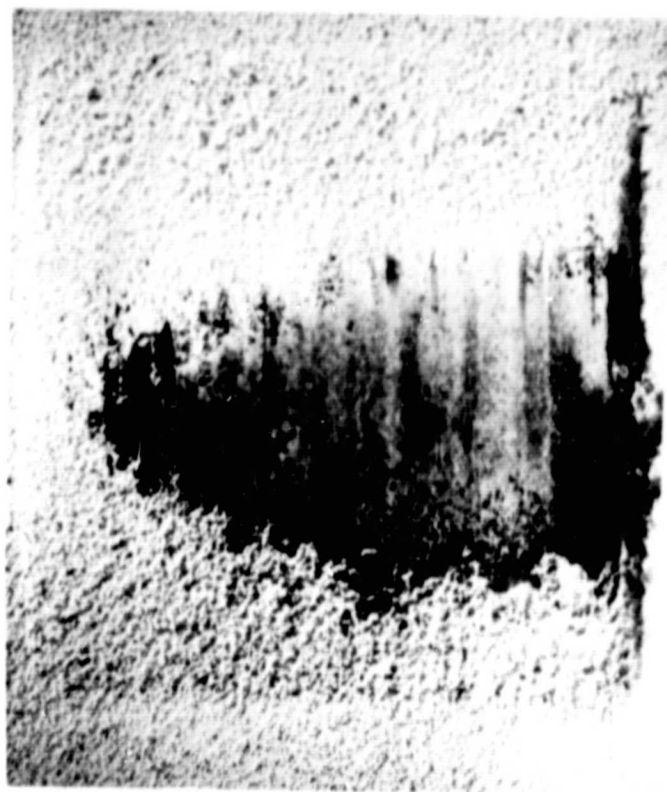
Blade track wear scar

Incursion rate:
.0025 cm/sec
(.001 in/sec)

Blade tip speed:
229 m/sec
(750 ft/sec)

Blade tip condition

Figure 10 Slow incursion rate abrasability test results for specimen configuration III-P Magn: 5X

Figure 10 shows the slow incursion rate abrasability results for the III-P materials system. This was a well-defined clean rub trace with no evidence of glazing or transferred metal on the surface of the abrasable material. The blade tip condition was excellent with no evidence of any distress present. No loss of blade tip material could be measured. The depth of rub was 0.038 cm (0.015 in.).

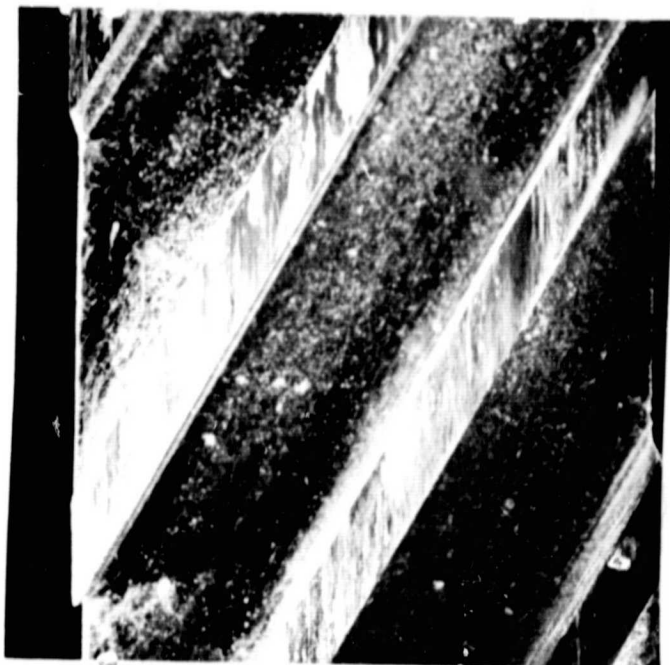
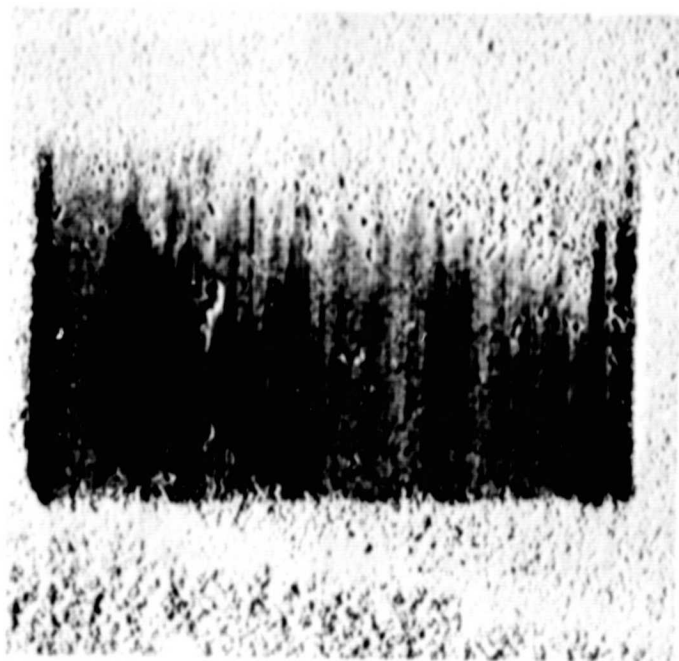
Blade track wear scar

Blade tip condition

Incursion rate:
.025 cm/sec
(.010 in/sec)

Blade tip speed:
229 m/sec
(750 ft/sec)

Figure 11 Fast incursion rate abrasability test results for specimen configuration I-P Magn: 5X

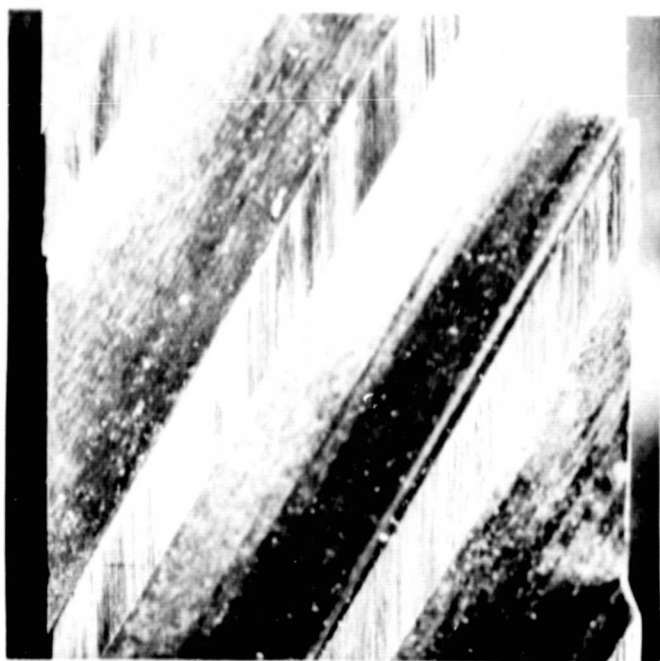
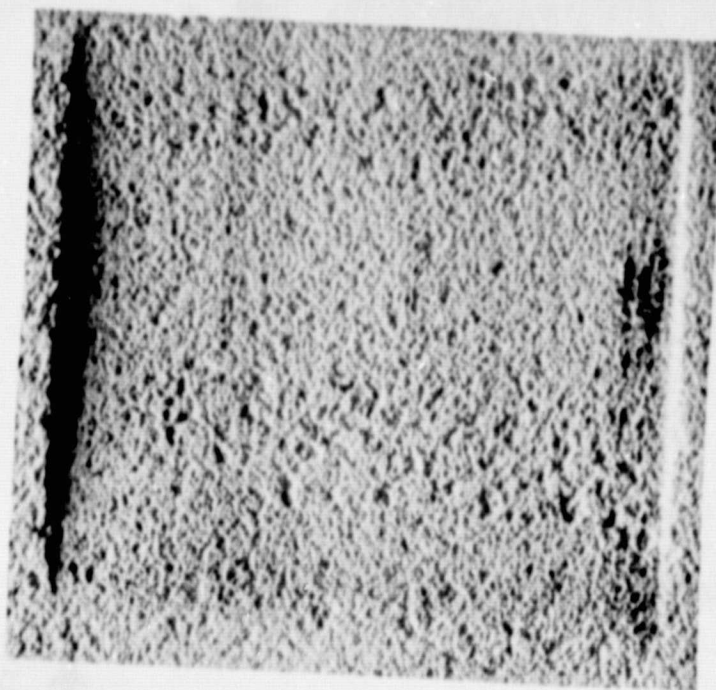
Blade track wear scar

Incursion rate:
.025 cm/sec
(.010 in/sec)

Blade tip speed:
229 m/sec
(750 ft/sec)

Blade tip condition

Figure 12 Fast incursion rate abrasability test results for specimen configuration II-P Magn: 5X

The result of the fast incursion rate abrasability test with the II-P material system is shown in Figure 12. Glazing of the material occurred almost immediately upon contact, accompanied by thermal cracking at the surface of the rub path and some particle pullout. No metal debris could be seen in the rub track. The blade tip shows severe burnishing and visual indications of streaking, but there was little evidence of any physical scoring or galling taking place. The measured rub depth was 0.013 cm (0.005 in.) and the maximum blade tip loss was .0015 cm (.0006 in.).

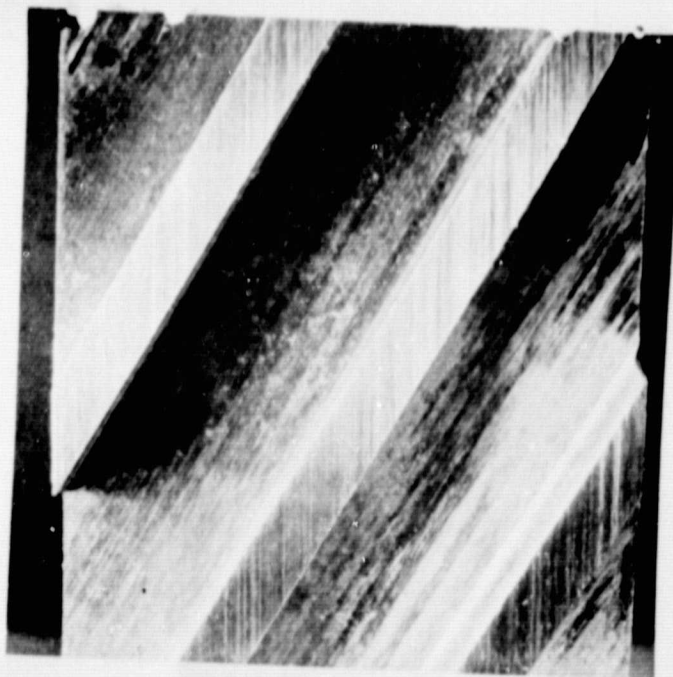
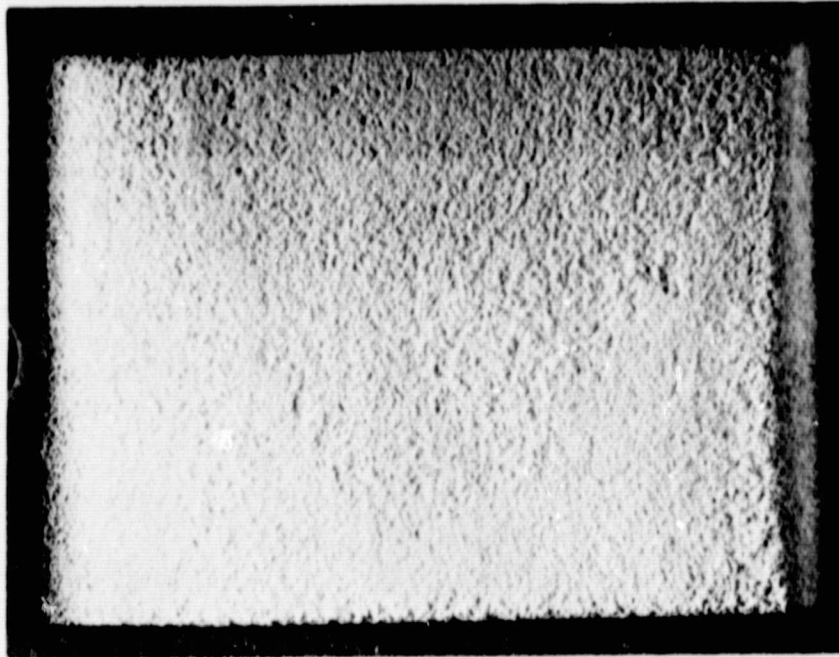
Blade track wear scar

Blade tip condition

Incursion rate:
.025 cm/sec
(.010 in/sec)

Blade tip speed:
229 m/sec
(750 ft/sec)

Figure 13 Fast incursion rate abrasability test results for
specimen configuration III-P Magn: 5X

Figure 13 shows the condition of the rub track and the blade tips for the fast incursion rate with the III-P materials system. The rub track was very clean and distinct except for a slight amount of metal pickup at one edge of the rub path. The blade tip shows no evidence of distress and no burnishing is present. The maximum amount of blade tip loss was 0.0025 cm (0.001 in.) and the depth of penetration in the abradable layer was 0.041 cm (0.016 in.).

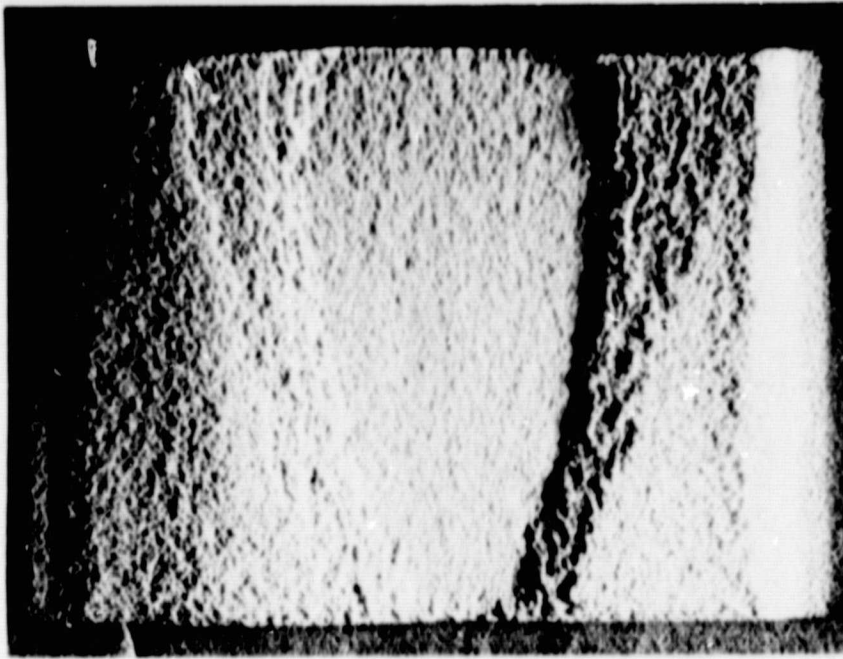
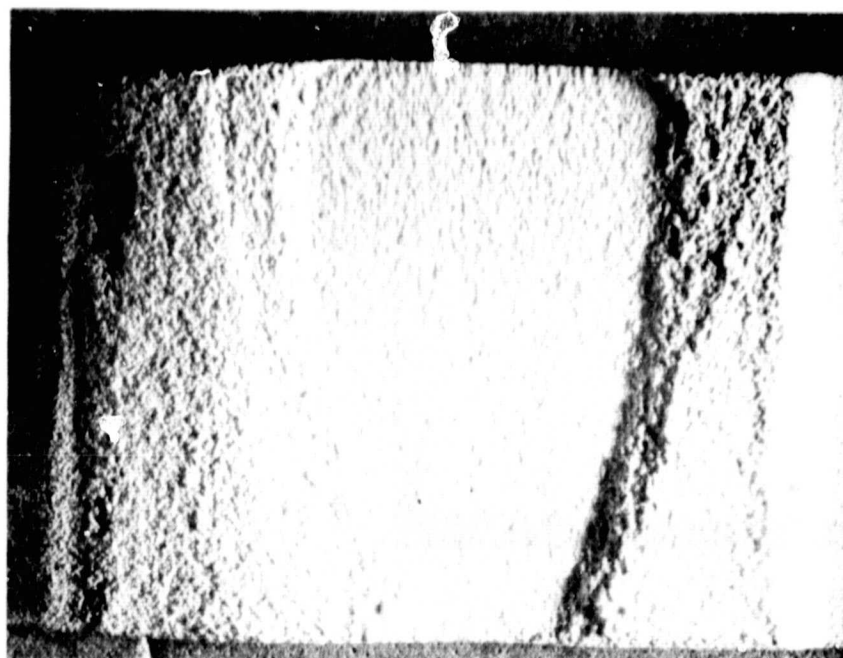
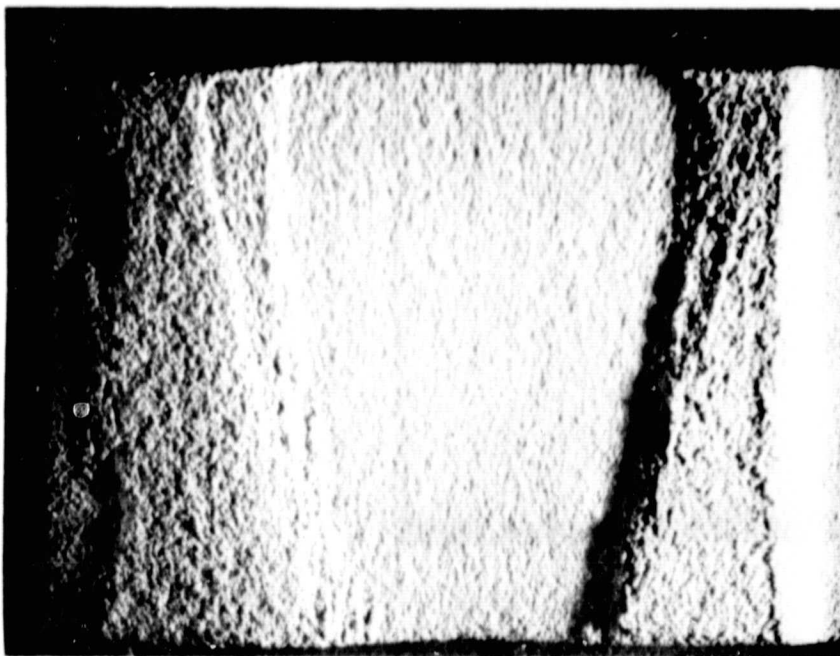
a. As machined plus thermal decomposition of filler

b. 30 min. exposure (12.5 gm abrasive)

Figure 14 Development of accelerated erosion wear scar with time for coating system I-P Magn: 3X

c. 60 min. exposure (27.5 gm abrasive)

d. 120 min. exposure (41.7 gm abrasive)

Figure 14 (cont'd) Development of accelerated erosion wear scar with time for coating system
I-P Magn: 3X

Erosion tests were performed on each of the sample systems in accordance with the test description and apparatus previously described. A particularly unusual phenomenon occurred with the I-P system which can be observed in Figures 18 a through d. A layering of the coating took place during fabrication and was immediately observed after machining the samples, Figure 14a. This layering could also be observed in the erosive patterns produced, as seen in Figures 14 b, c, d. This did not occur in any of the other systems and is believed to be an inconsistency in the plasma spray process, possibly resulting from spray technique employed in fabricating early specimens. It is also noted that the I-P system experienced the most severe total erosion damage of all the systems as well as the highest rate of damage. In the first 30 minute period, the sample was virtually eroded away to the more dense YSZ sub-layer. Erosion of the II-P coating system is shown in Figures 15a through d. The layering observed in the I-P coating, Figure 14a, was not present in the II-P coating, Figure 15a. Improved erosion resistance of the II-P coating over the I-P system can be observed as early as the completion of the 30 minute test (Figures 15b compared to Figure 14b). Erosion of the III-P coating system, shown in Figures 16a through d, behaved similar to the I-P system. The specific erosion resistance plotted as a function of time is shown for all the systems in Figure 17.

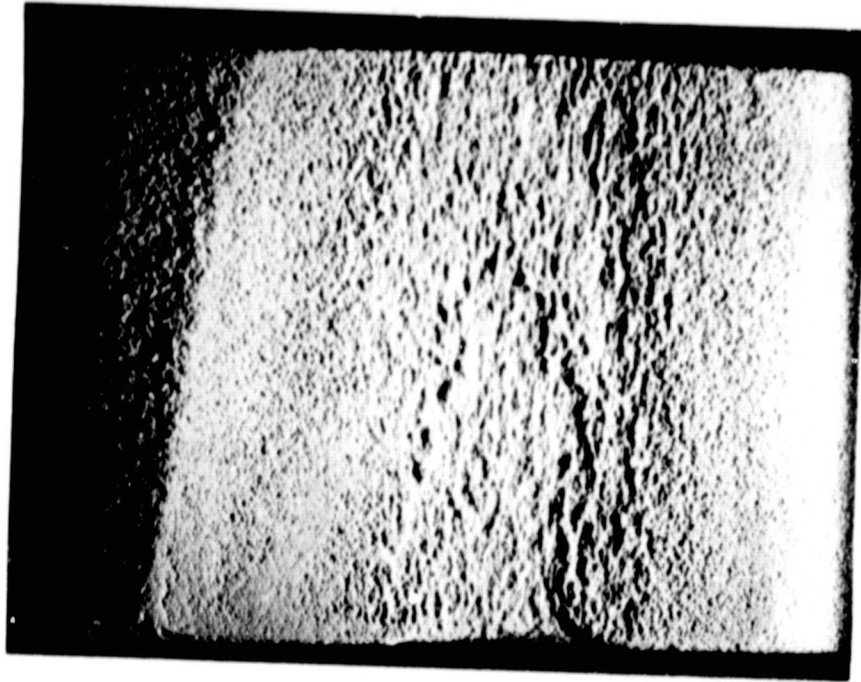
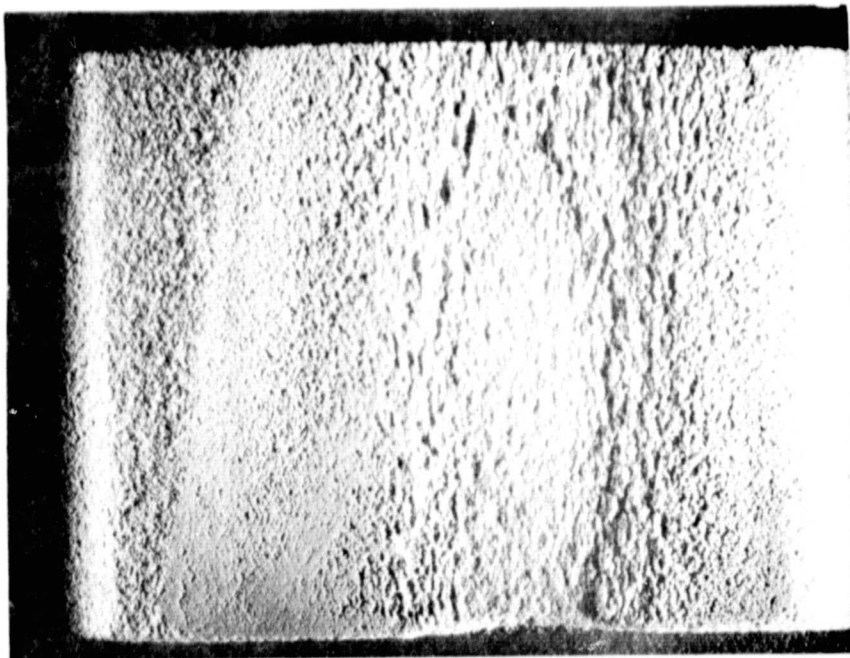
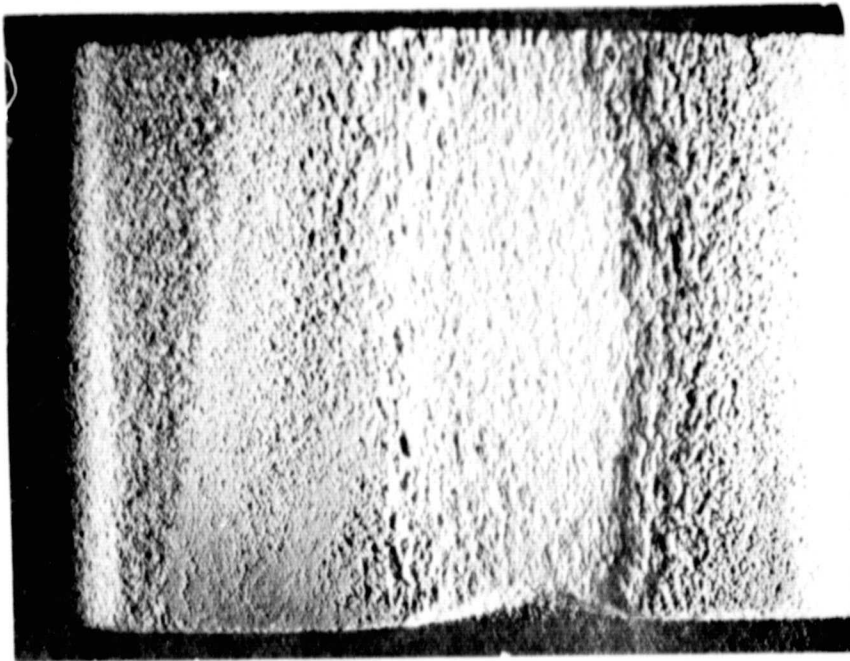
a. As machined plus thermal decomposition of filler

b. 20 min. exposure (13.4 gm abrasive)

Figure 15 Development of accelerated erosion wear scar with time for coating system II-P Magn: 3X

c. 60 min. exposure (19.1 gm abrasive)

d. 120 min. exposure (37.8 gm abrasive)

Development of accelerated erosion wear scar with time for coating system II-P
Magn: 3X

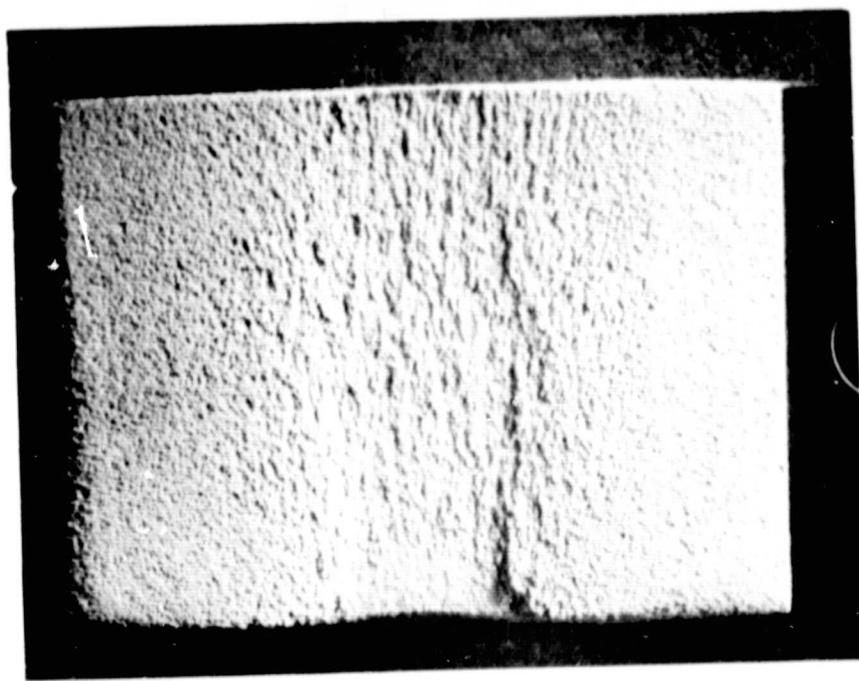
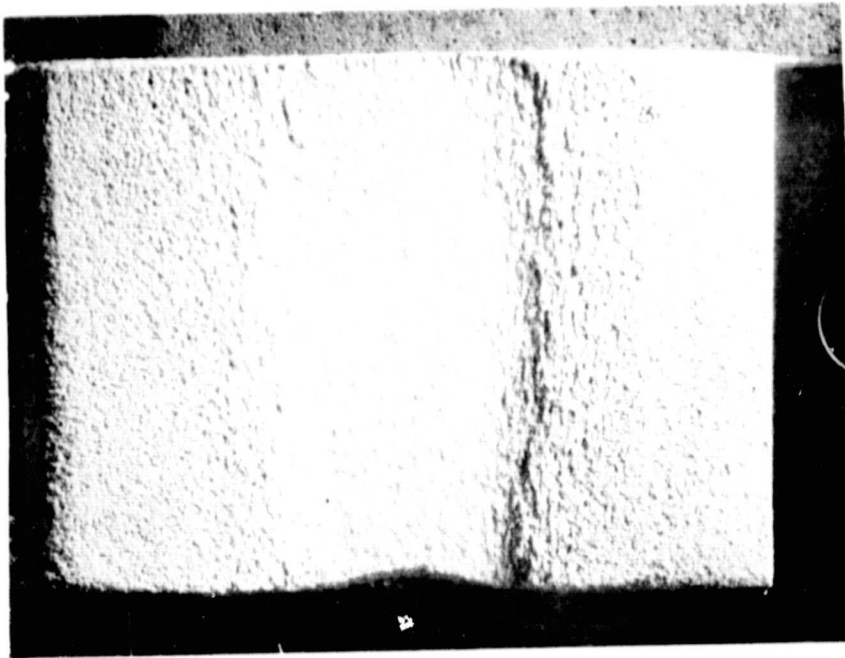
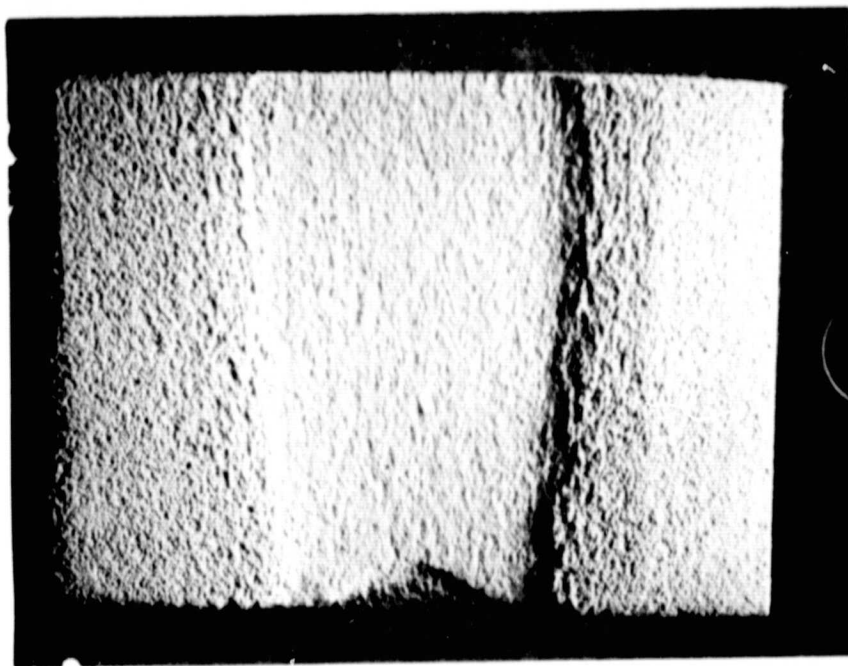
a. As machined plus thermal decomposition of filler

b. 30 min. exposure (7.4 gm abrasive)

Figure 16 Development of accelerated erosion wear scar with time for coating system III-P Magn: 3X

c. 60 min. exposure (18.4 gm abrasive)

d. 120 min. exposure (45.8 gm abrasive)

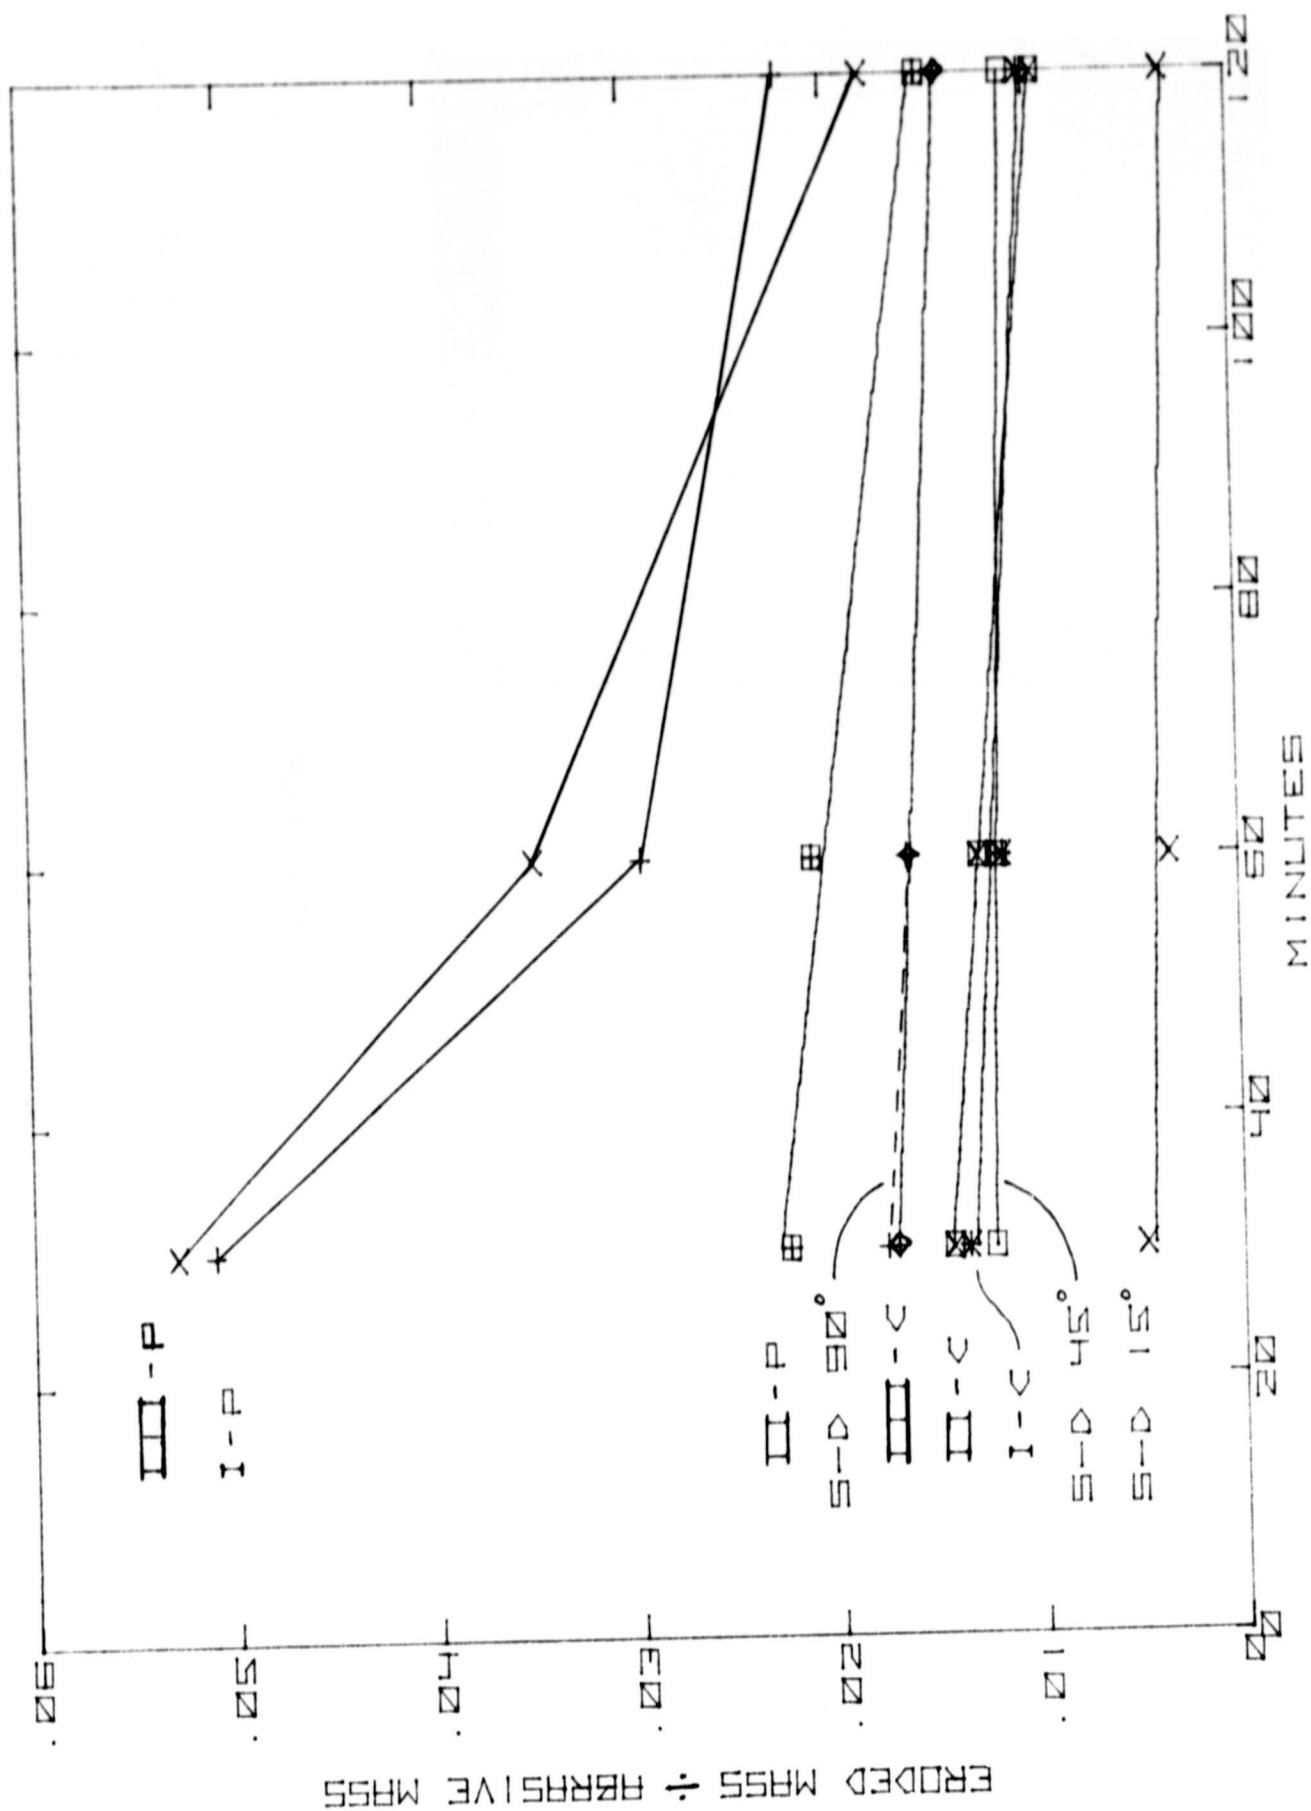
Figure 17 Erosion of Polyester and Cenosphere filled YSZ systems
